Inspection Report

SAMPLE REPORT

Property Address:
SAMPLE REPORT
Blaine MN

Date: 4/27/2020	Time: 11:00 AM	Report ID: 20200427-3312-W-2nd-Ave-N
Property: SAMPLE REPORT Blaine MN	Customer: SAMPLE REPORT	Real Estate Professional:

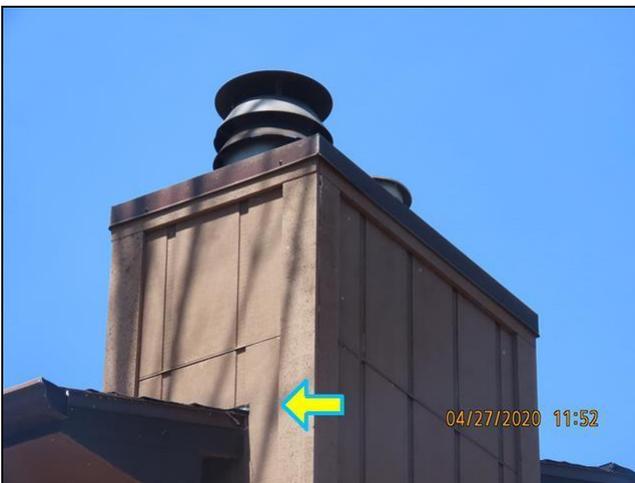
1.2 Item 1(Picture)

(1) A wall section at the of the home had no kick-out flashing installed where a wall extended past a roof edge. This condition may allow moisture intrusion of the exterior wall covering. The Inspector recommends correction by a qualified contractor to reduce chance of wood rot in nearby areas.

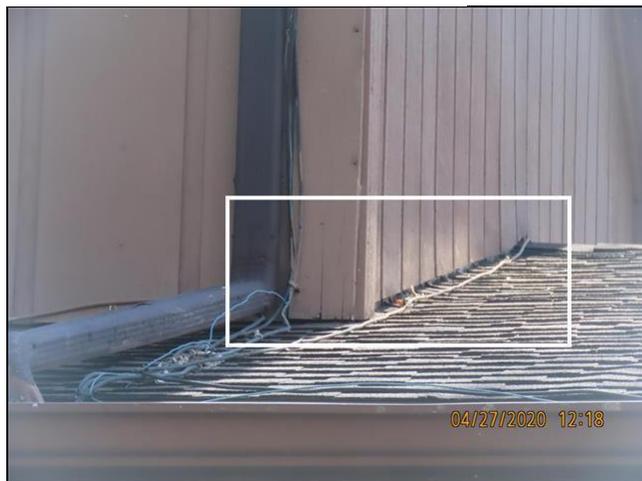
(2) Head wall/sidewall counter-flashing was not installed which may increase chance of nearby wooden components to age or deteriorate from high moisture levels. A contractor can provide options and costs for corrections as needed.

1.2 Item 2(Picture) side wall / head wall counter flashing not installed.

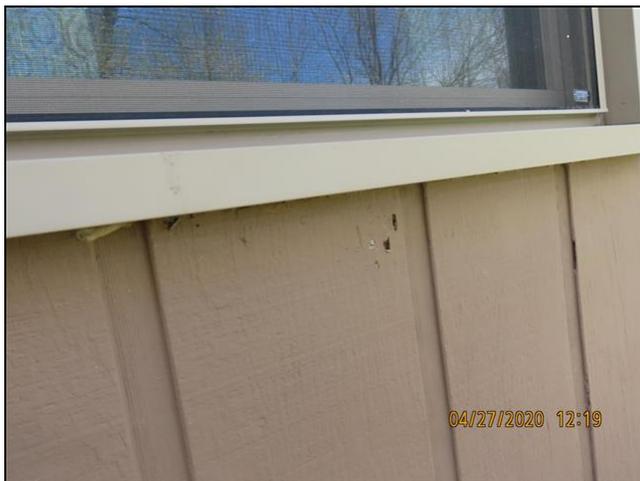
2.2 Item 1(Picture)

(1) No flashing was installed where wood siding ended and a different exterior wall covering material began. This condition may result in moisture intrusion of the wall structure assembly. Damage such as decay of wood structural members may not be visible without invasive measures. The Inspector recommends installation of an appropriate sealant by a qualified contractor.

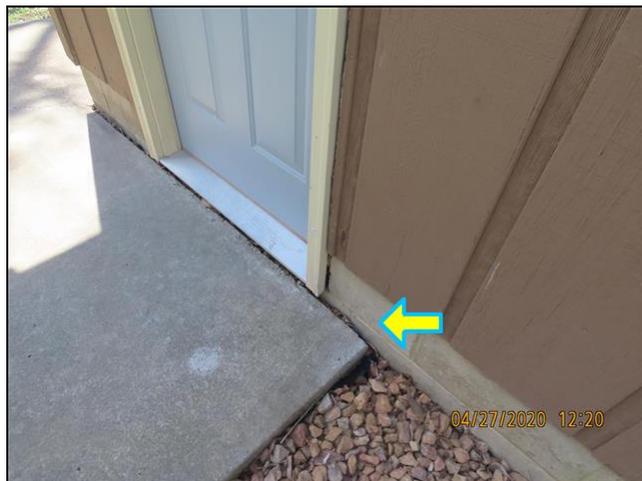
2.6 Item 1(Picture)

(2) The joint at which concrete walkways met the exterior walls should be maintained. Gaps and cracks should be sealed to reduce chance of further cracking or moisture near the foundation.

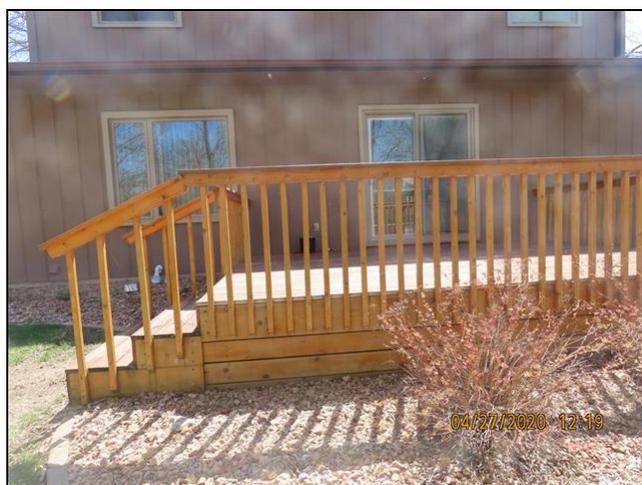
- Exterior stairs should be maintenance to increase life span.
- Item 1(Picture) Areas of the deck were in contact with soil at front and rear of home. This condition will result in damage from decay. The inspector recommends correction to extend the service life of this deck.
- Finish coating designed to protect the deck at front and rear of home was not present. Failure to apply a finish coating will allow Ultra Violet (UV) radiation from sunlight, heat, moisture and freezing moisture to reduce the life span of bare wood exposed to weather. Maintenance performed on an appropriate schedule can significantly extend the life span of wood deck components. The Inspector recommends that wood components be re-finished as needed.
- The deck at rear of home showed moderate wear and tear commensurate with age.

2.8 Item 1(Picture) rear of home

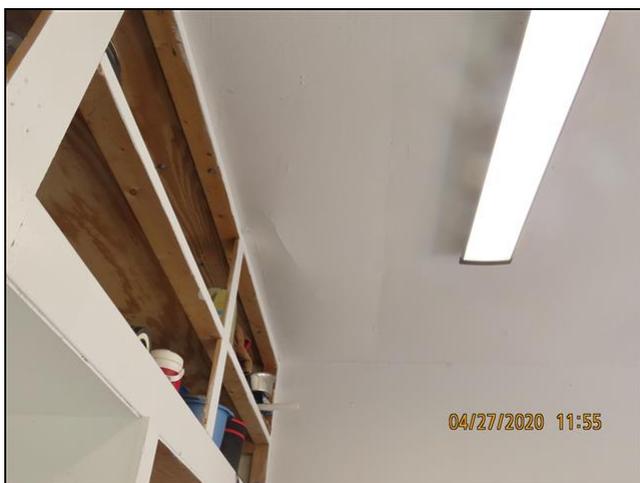
3.2 Item 1(Picture)

- Damage to the garage ceiling and localized area Observed at time of inspection. The FLIR Thermal camera indicated possible missing insulation in this area . You may wish to ask seller about this condition or have a qualified contractor confirm this finding and to ensure proper conditions exist year round.
-

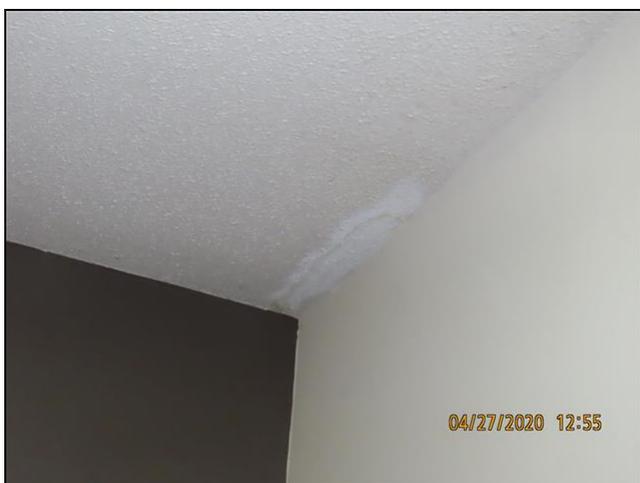
- Cracks in areas at interior of home appeared to be the result of long-term settling. Determining future cracking goes beyond the scope of an inspection.
- Light damages observed at master bedroom and upstairs hallway ceiling appear cosmetic.
- Item 1(Picture) upstairs hallway bedroom ceiling - repairs observed in areas, you may wish to ask seller about this finding. The area was dry at time of inspection. Determining future moisture goes beyond the scope of a home inspection.

4.3 Item 1(Picture) upstairs hallway bedroom ceiling

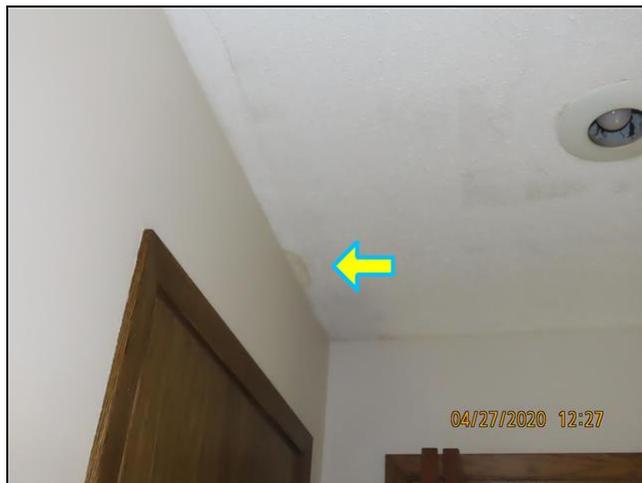
4.3 Item 2(Picture) stain at ceiling near rear entry (leading to garage), area appeared to have been recently painted

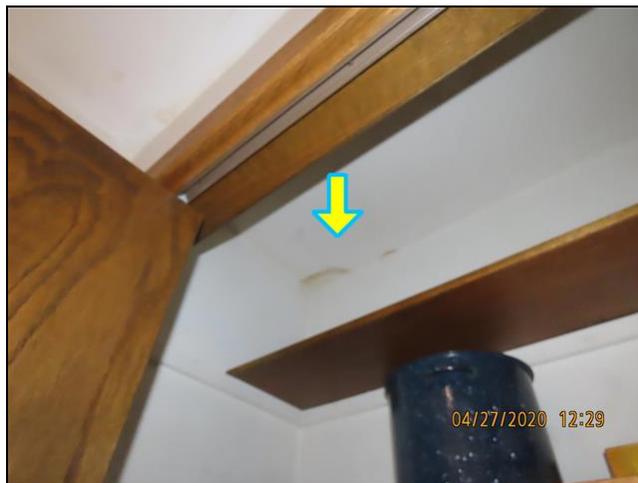
4.3 Item 3(Picture) stain at ceiling near rear entry (leading to garage), in closet

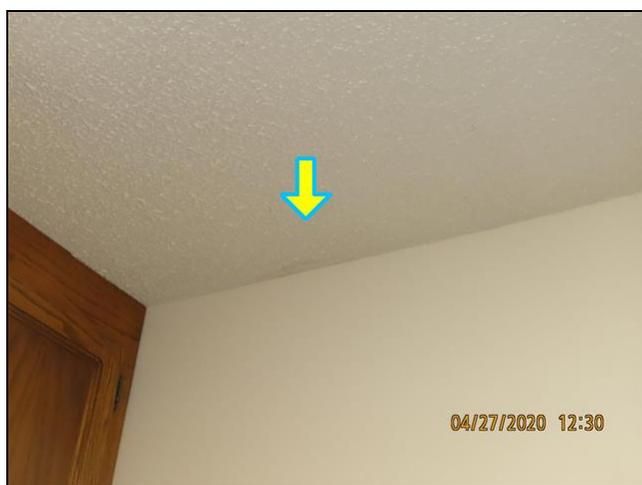
4.3 Item 4(Picture) stain at ceiling, laundry room ceiling

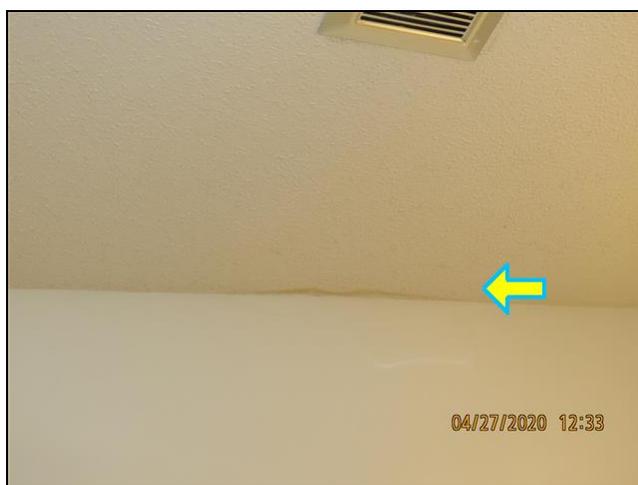
4.3 Item 5(Picture) main floor bathroom ceiling (2 locations)

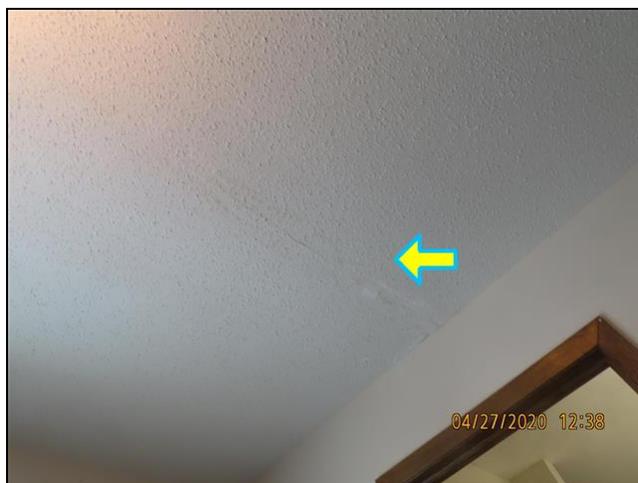
4.3 Item 7(Picture) stain, damage - living room ceiling

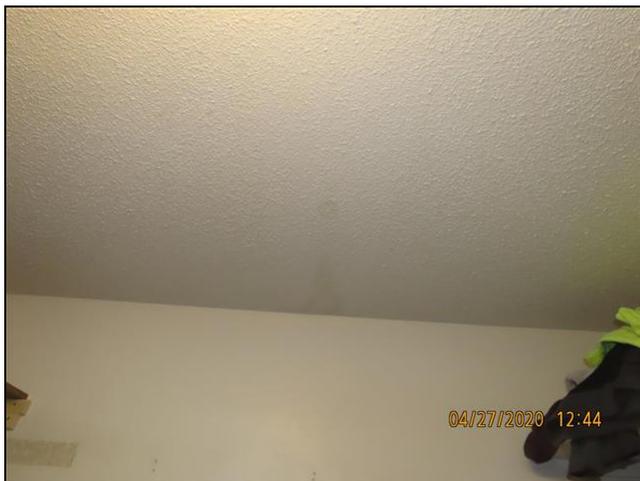
4.3 Item 8(Picture) main floor (master bedroom) closet

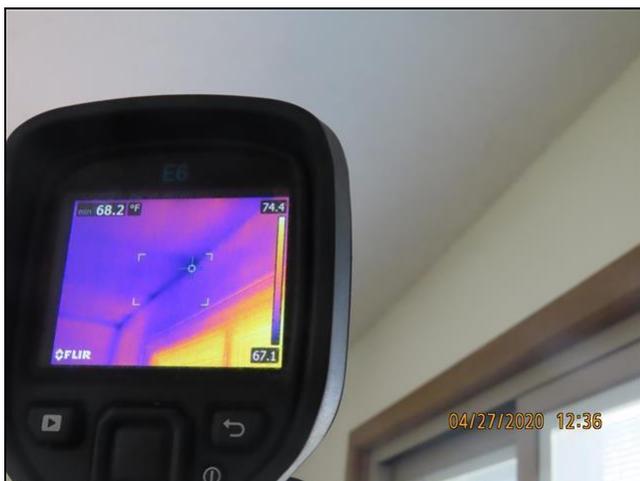
- Item 10(Picture) stain at dining room ceiling - appears to have energy loss in the area. Further evaluation of all moisture stains should be further evaluated.

4.3 Item 10(Picture) stain at dining room ceiling

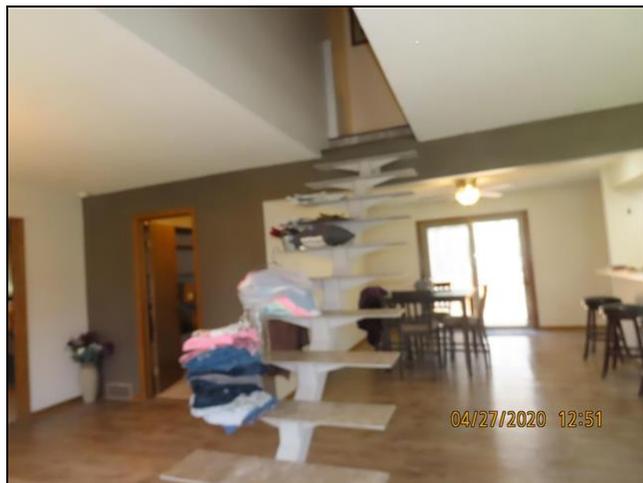
4.8 Item 1(Picture)

Missing handrail leading to basement can create a potential fall hazard, especially for the elderly or young children. A handrail should be installed to protect this stairway by a qualified person or professional.

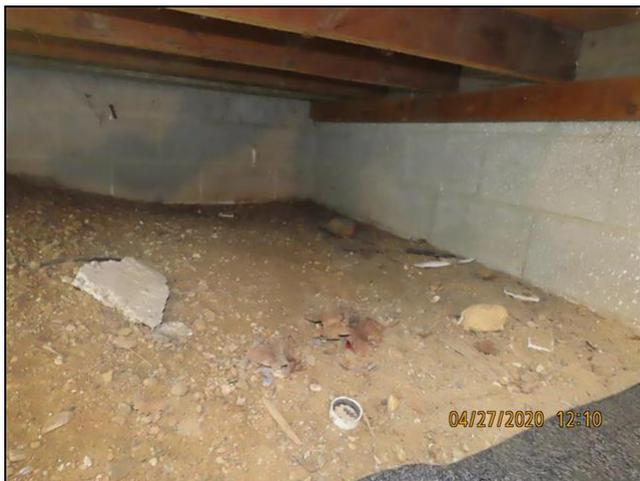
5.4 Item 1(Picture)

(1) The crawlspace, access located in the garage, did not appear to have a full vapor barrier. Inspector recommends a full vapor barrier near the entrance to reduce chance of moisture or possible harmful gases.

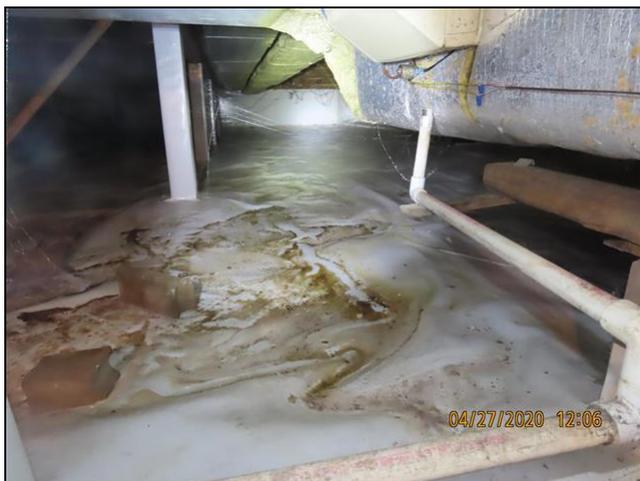
5.4 Item 2(Picture)

(2) Stains on the floor (active in localized areas) in the crawlspace visible at the time of the inspection appeared to be the result of moisture. The moisture meter showed elevated moisture levels in the affected areas at the time of the inspection, indicating that the leakage has been recent. The Inspector recommends consultation with a qualified contractor to discuss options and costs for correction and repair.

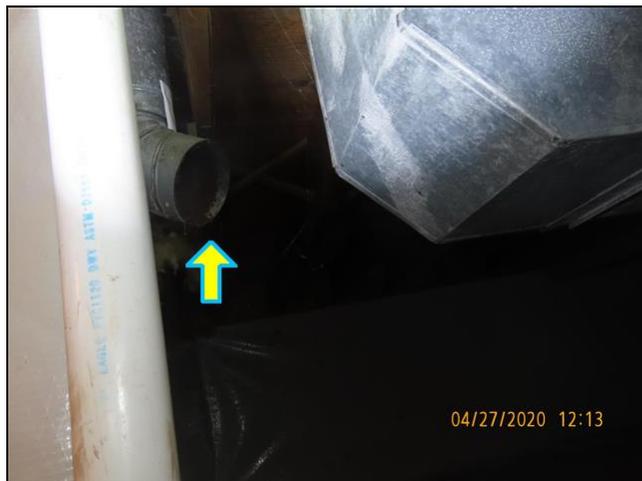
5.4 Item 3(Picture)

(4) Inspector observed a vent in the crawlspace that appeared to be connected (in use) with the laundry room. This condition may result in un-favorable conditions such as high moisture level which can lead to microbial growth or moisture damages. Inspector recommends further evaluations to ensure proper conditions exist by a qualified professional or HVAC contractor.

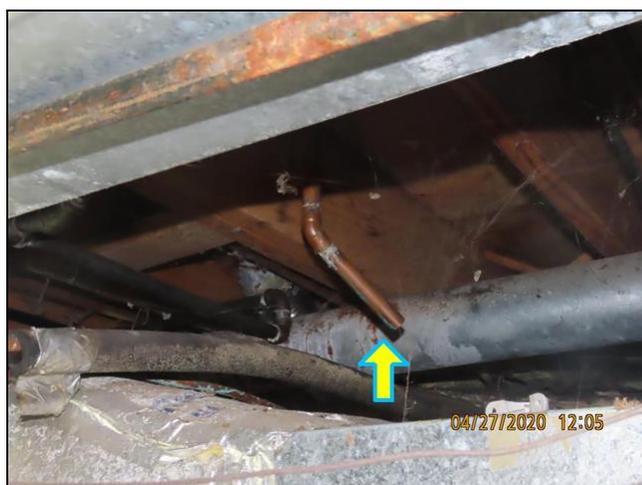
6.2 Item 1(Picture)

- It appears a discharge pipe drains to the crawl space which may create moisture damage.
- Work performed by persons on familiar with standards of practice may contain hidden defects.

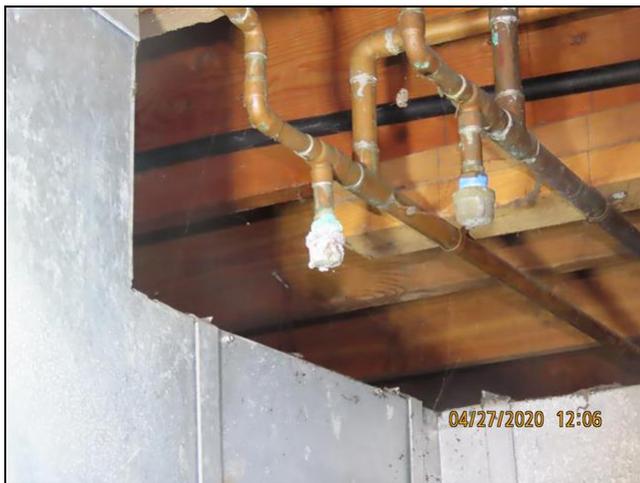
(2) Inspector observed two or more localized area(s) of corrosion at copper pipe. Failure to replace the corroded component(s) may result in failure that can cause water damage. Monitor the pipes on a regular basis to prevent future damage from active leaking. To avoid problems in the future you may wish to have the corroded sections replaced by a qualified contractor.

6.2 Item 2(Picture) crawlspace

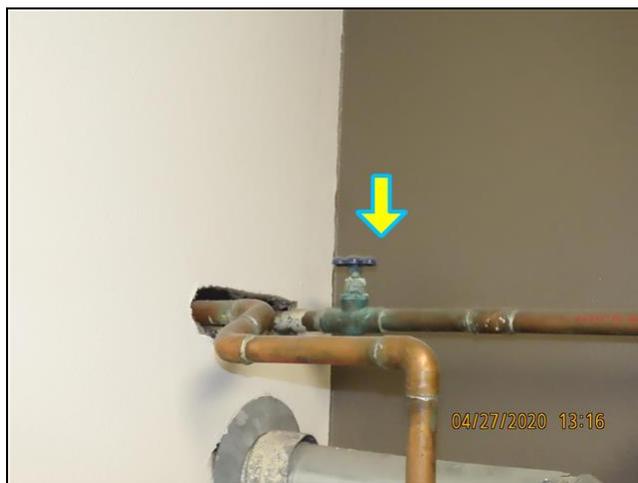
6.2 Item 5(Picture) corrosion near water heater

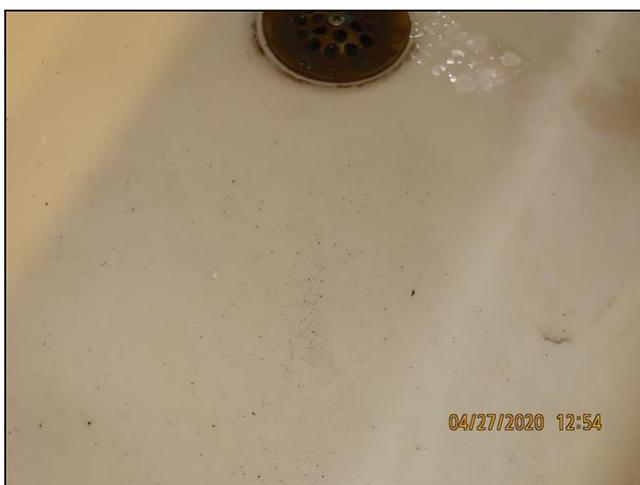
(3) Inspector observed what appeared to be debris in the water supply at upstairs bathroom when the water source was turned on. Determining exact cause goes beyond the scope of a home inspection. A qualified plumber should confirm this finding to ensure proper conditions exist.

6.2 Item 6(Picture) debris in water supply, upstairs bathroom

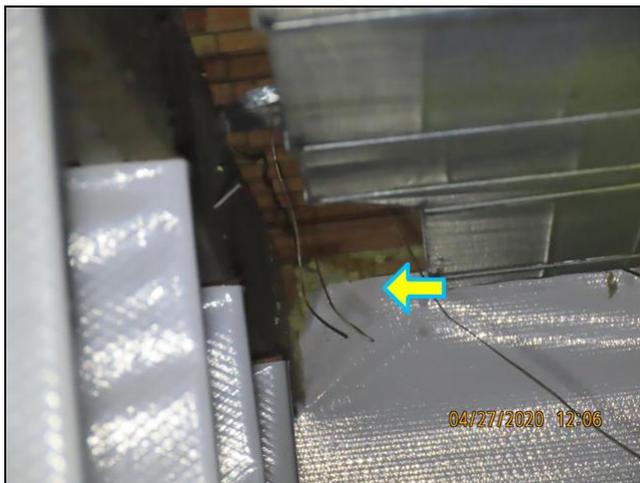
- Item 1(Picture) Abandoned electrical component(s) in the crawlspace is indication that for their evaluation is needed by a qualified electrician to ensure proper conditions exist.

7.0 Item 1(Picture) exposed wiring, visible from crawlspace

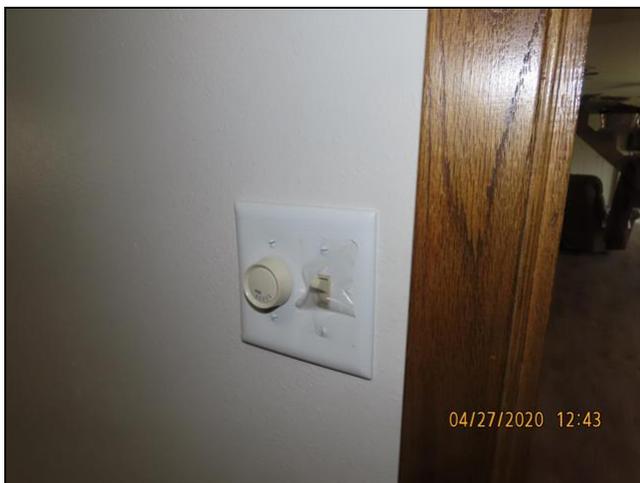
- Item 1(Picture) master bedroom light switch taped, you may wish to ask seller about this finding.

7.5 Item 1(Picture) master bedroom light switch taped

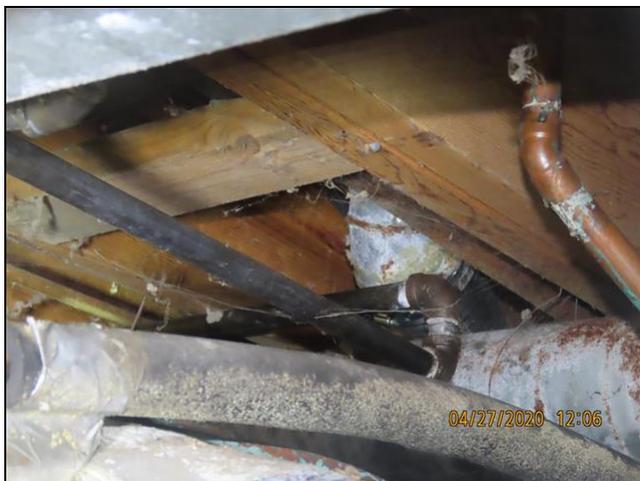
(2) Corrosion observed at two or more supporting components of the furnace, (at ductwork in crawlspace). This is indication that high humidity levels may exist. The area was dry at time of inspection however in HVAC technician can confirm this finding and ensure the source of moisture is not intermittent.

8.1 Item 2(Picture) Corrosion at duct work visible from crawlspace

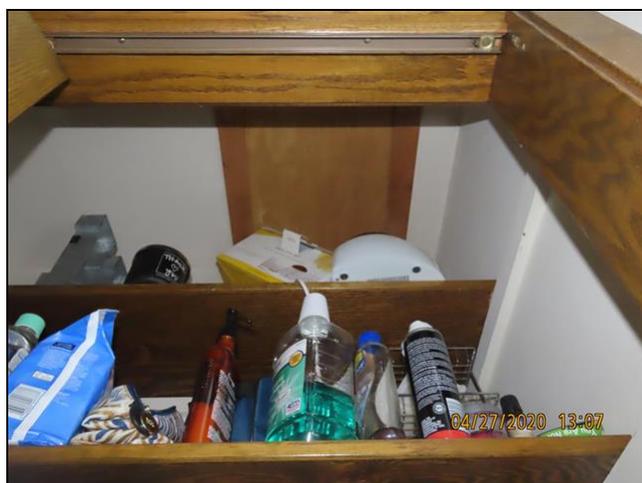
9.0 Item 1(Picture)

(2) One of the attic access hatch's was located in a closet and access was blocked by the occupant's belongings. Moving stored items lies beyond the scope of the General Home Inspection. The Inspector recommends that the attic be inspected after access to the attic entry hatch has been provided.

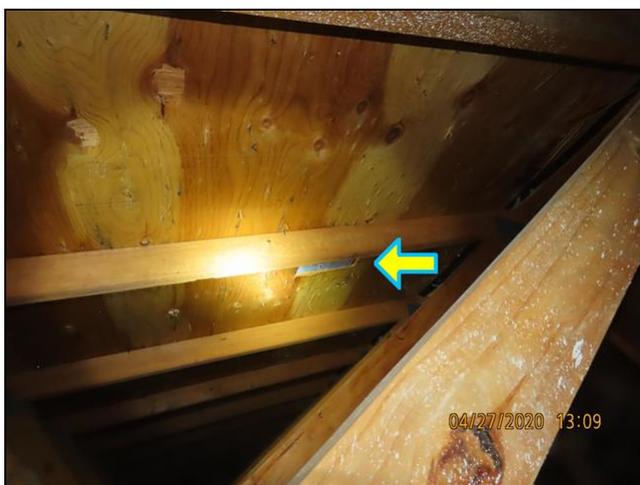
9.3 Item 1(Picture)

- Item 1(Picture) It appeared as if one of the old roof vent(s) had been removed.
- Monitor for frost/moisture on windows during window. If high humidity levels occur steps should be taken for correction.

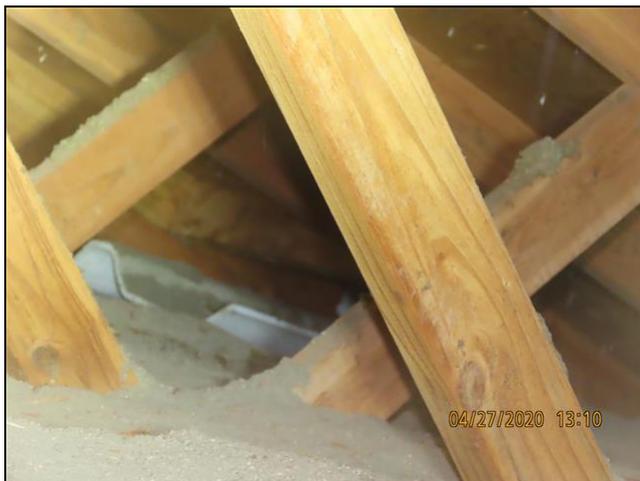
9.8 Item 1(Picture)

Attic had localized area of discoloration that appeared to be the result of roof leakage. I am not able to determine if leaks still exist due to lack of rain. Sheathing did not have elevated moisture levels at the time of the inspection. The source of the leak appeared to have been corrected or may be weather related. A qualified contractor should further evaluate and confirm leak has been corrected.

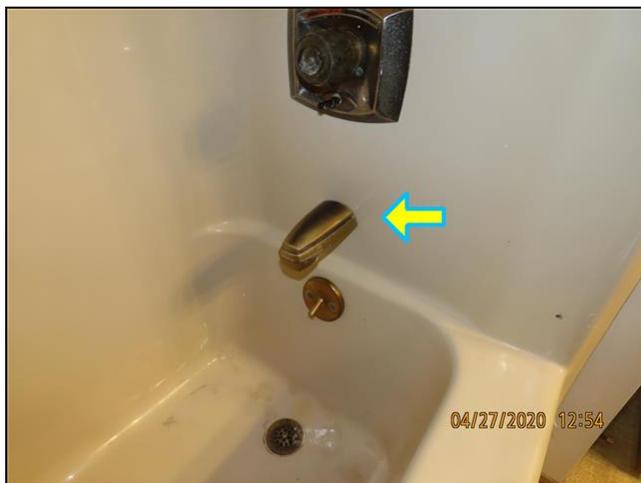
Inspector observed what appeared to be an act of we got upstairs bathroom hardware. Inspector recommends correction as needed by a qualified professional or plumber to ensure proper conditions exist.

10.0 Item 1(Picture) upstairs bathroom

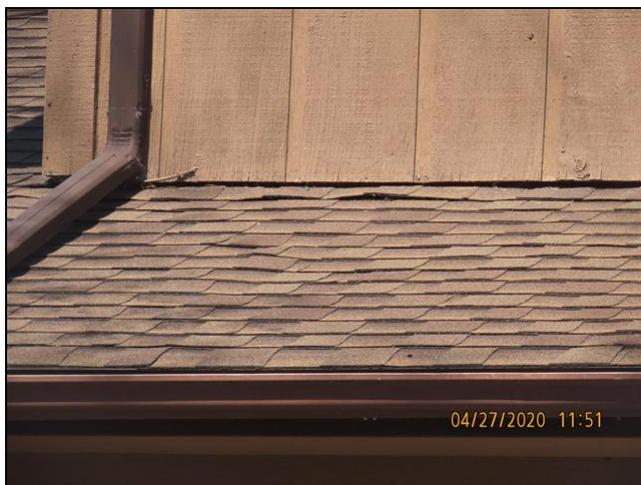
(3) Inspector observed lifted shingles in localized area. Recommend proper maintenance or further evaluation as needed by a qualified roofing contractor. This is a likely entrance plate for moisture.

1.0 Item 1(Picture) front of home

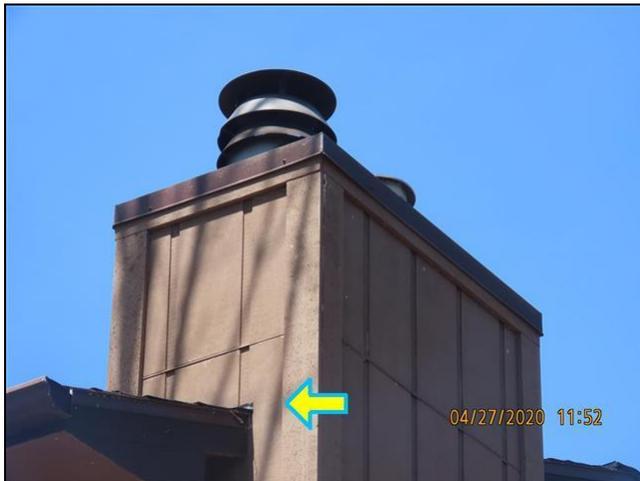
1.2 Item 1(Picture)

(1) A wall section at the of the home had no kick-out flashing installed where a wall extended past a roof edge. This condition may allow moisture intrusion of the exterior wall covering. The Inspector recommends correction by a qualified contractor to reduce chance of wood rot in nearby areas.

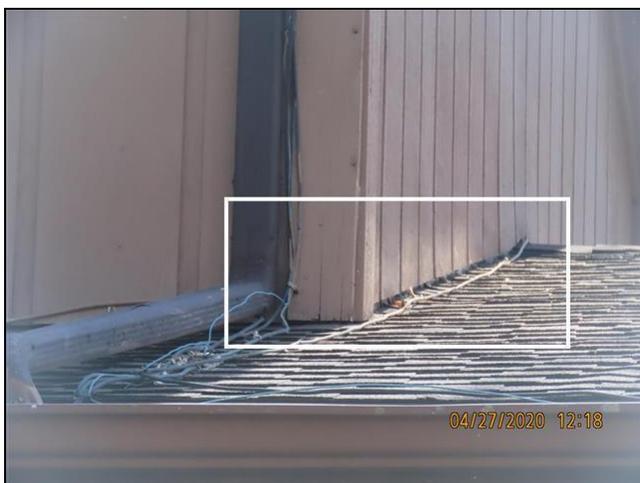
(2) Head wall/sidewall counter-flashing was not installed which may increase chance of nearby wooden components to age or deteriorate from high moisture levels. A contractor can provide options and costs for corrections as needed.

1.2 Item 2(Picture) side wall / head wall counter flashing not installed.

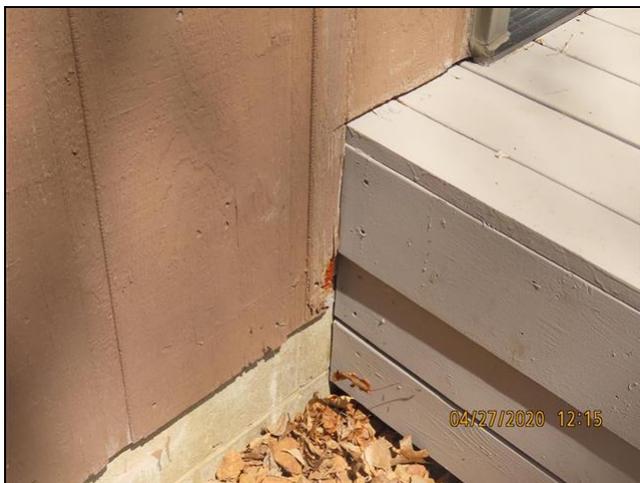
exterior wall covering material. The Inspector recommends further evaluation by a qualified contractor to ensure proper conditions exist.

2.8 Item 2(Picture) lack of flashing at deck(s)

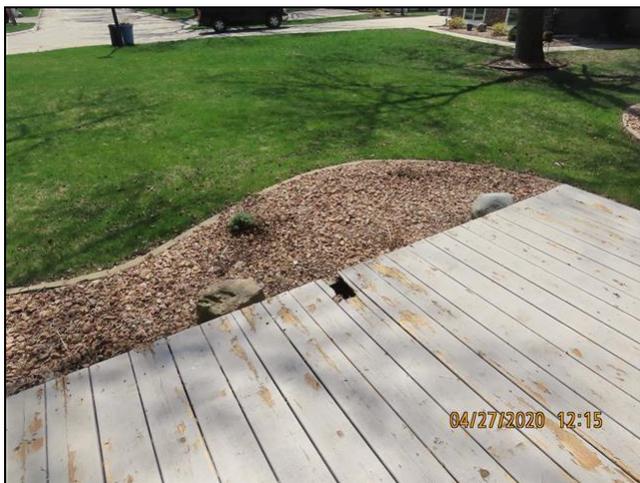
2.8 Item 3(Picture)

- The finishing coat was damaged/missing.
- Wood rot observed in several areas.
- You may wish to install a safety railing, this is not a requirement.
- Inspector observed what appeared to be to deflection, movement of the wood deck components when walked upon, this is indication for their evaluation is needed to determine the extent of wood rot.

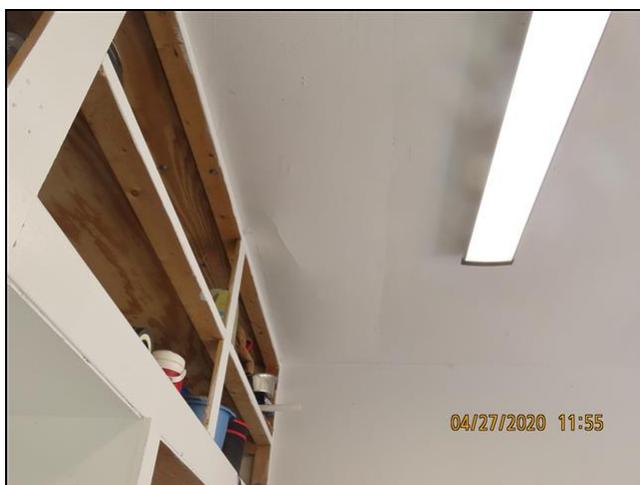
3.2 Item 1(Picture)

- Damage to the garage ceiling and localized area Observed at time of inspection. The FLIR Thermal camera indicated possible missing insulation in this area . You may wish to ask seller about this condition or have a qualified contractor confirm this finding and to ensure proper conditions exist year round.

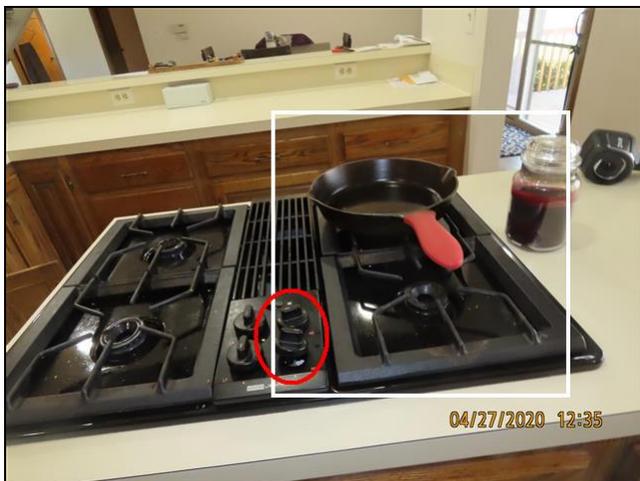
11.5 Item 1(Picture) two burners not responding, hardware damaged.
