Inspection Report

SAMPLE REPORT

Property Address:
SAMPLE REPORT
Blaine MN

Date: 4/27/2020	Time: 11:00 AM	Report ID: 20200427-3312-W-2nd-Ave-N
Property: SAMPLE REPORT Blaine MN	Customer: SAMPLE REPORT	Real Estate Professional:

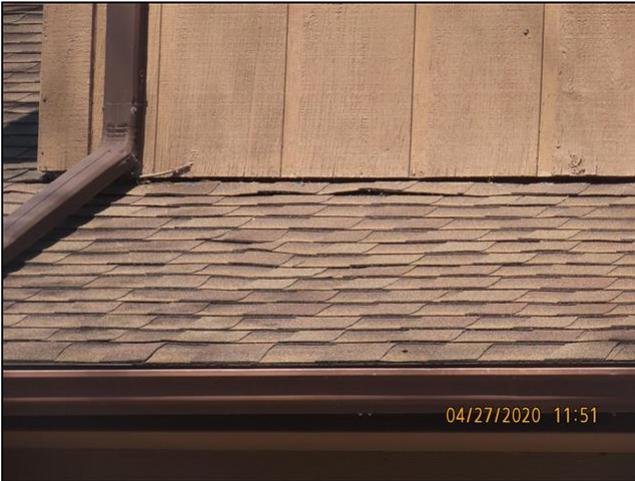
1.0 Item 1(Picture) front of home

(3) Inspector observed lifted shingles in localized area. Recommend proper maintenance or further evaluation as needed by a qualified roofing contractor. This is a likely entrance plate for moisture.

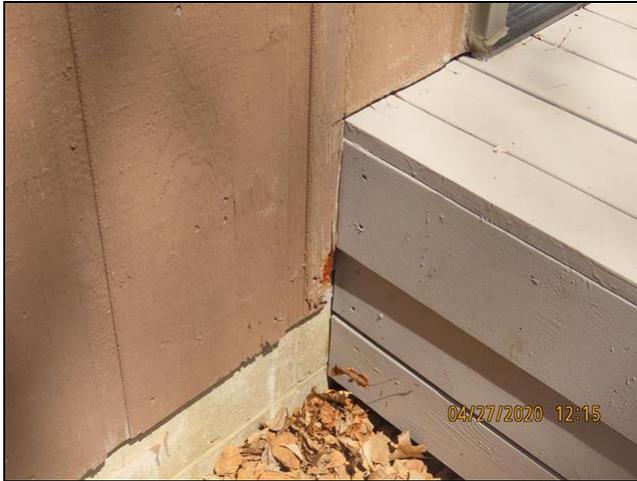
2.8 Item 2(Picture) lack of flashing at deck(s)

(2) The ledger attaching the deck(s) appeared to be inadequately flashed, no flashing was visible. Flashing is designed to protect the wall assembly from moisture intrusion where the attachment of the deck interrupts the home exterior wall

covering material. The Inspector recommends further evaluation by a qualified contractor to ensure proper conditions exist.

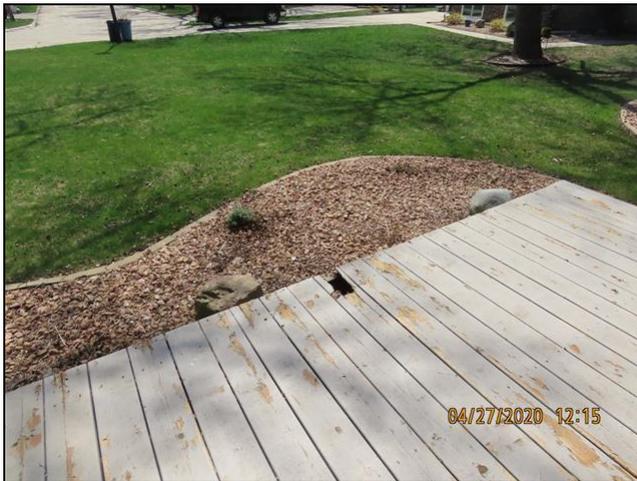
2.8 Item 3(Picture)

(3) The deck at front of home had a moderate to advanced wear and tear/wood rot, deterioration. You may wish to obtain a cost estimate for any and all repairs as needed by a qualified professional before the end of your inspection deadline.

- The finishing coat was damaged/missing.
- Wood rot observed in several areas.
- You may wish to install a safety railing, this is not a requirement.
- Inspector observed what appeared to be to deflection, movement of the wood deck components when walked upon, this is indication for their evaluation is needed to determine the extent of wood rot.

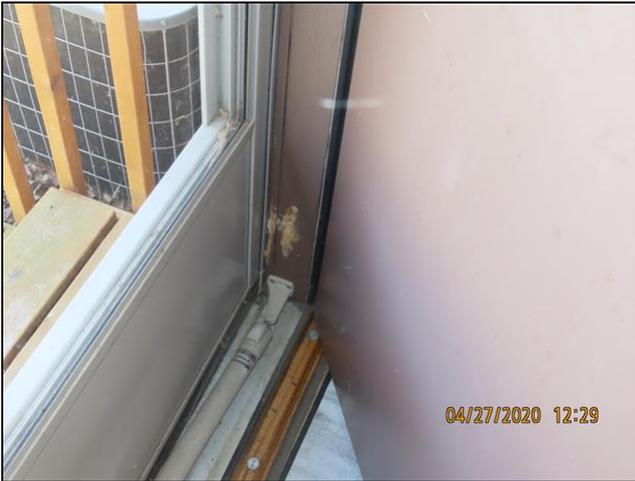
2.9 Item 1(Picture)

- Replace weather stripping and door sweeps to increase energy efficiency, general maintenance item.
- You should consider replacement or re-keying of locks for added security as desired.
- Item 1(Picture) General wear and tear observed.

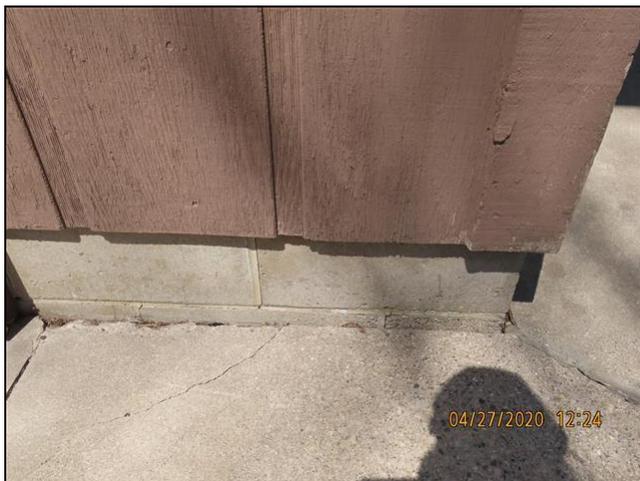
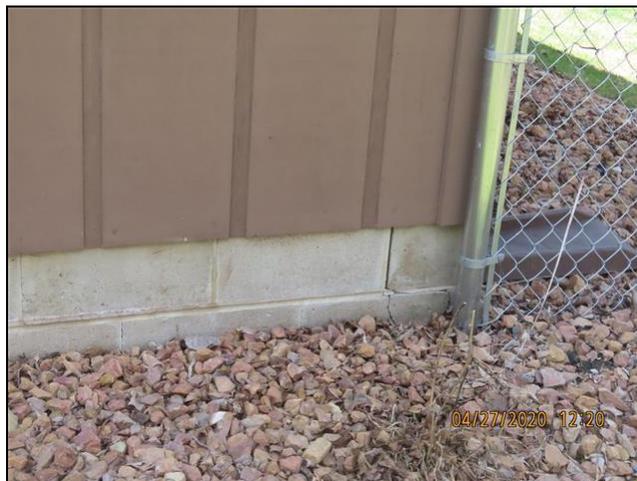
Inspector observed what appeared to be localized area(s) of cracking at the foundation wall, garage, right side and rear of home facing front.

- Inspector recommends proper sealant such as mortar or epoxy to reduce chance to further freeze cracking.
- If cracking continues a qualified contractor should provide options and costs for corrections as needed.
- Extend downspouts 6ft or more to reduce chance of further settlement.
- Downspouts in the area should be extended to reduce chance of further settlement.
- Long term proper maintenance will increase life span.

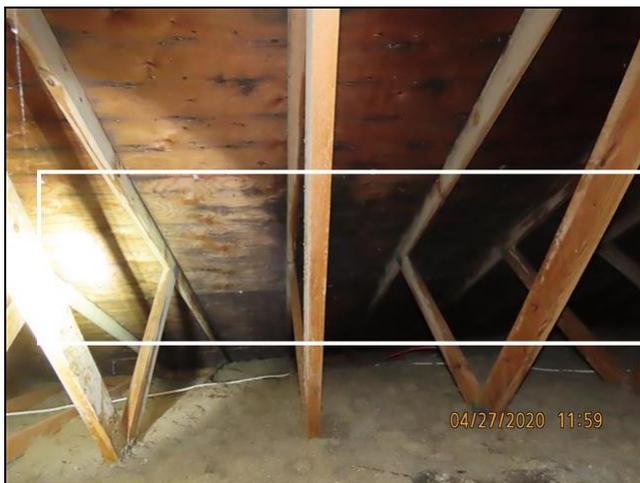
3.12 Item 1(Picture)

- Item 1(Picture) Item 4(Picture) Discoloration/staining in areas (appeared more than 15sq ft) - further evaluation needed to ensure dry conditions exist year round.
- Item 2(Picture) Deterioration in attic space in area(s) is indication of possible past/intermittent moisture or high condensation levels.
- Item 3(Picture) - Exposed electrical in 2 areas should be further evaluated by a qualified electrician to ensure proper conditions exist.

Inspector recommends for their evaluation of the attic space above the garage by a qualified contractor to ensure proper conditions exist. Determining future moisture goes beyond the scope of a home inspection.

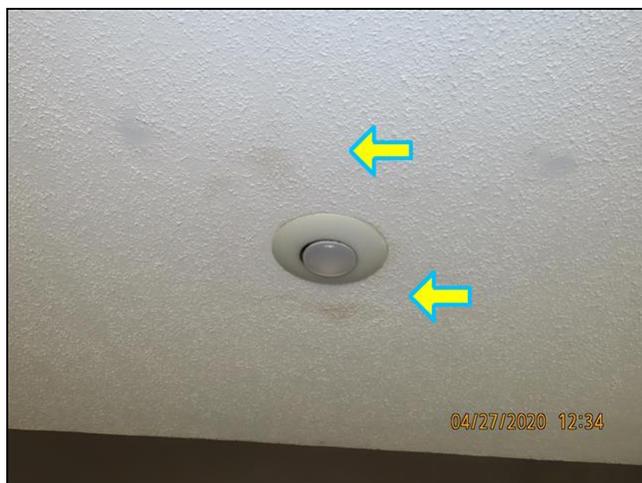
4.3 Item 6(Picture) kitchen ceiling

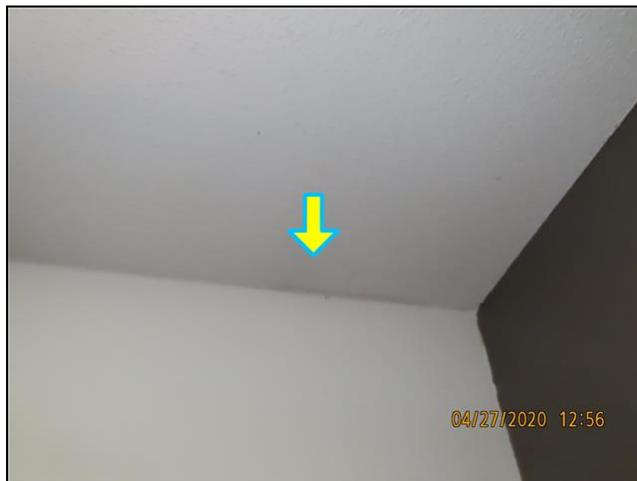
4.3 Item 9(Picture) upstairs hallway bedroom ceiling

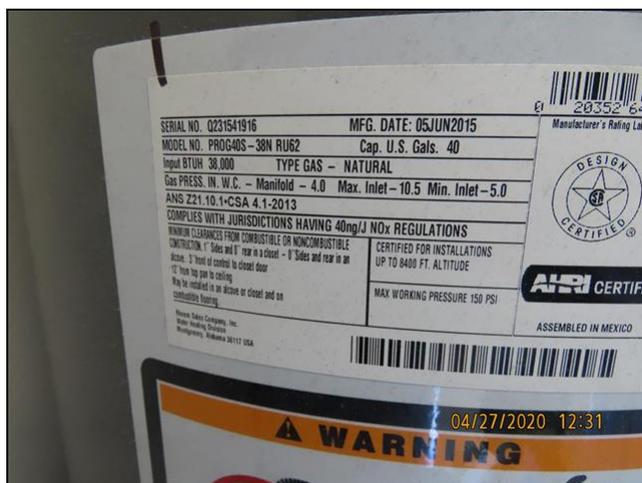
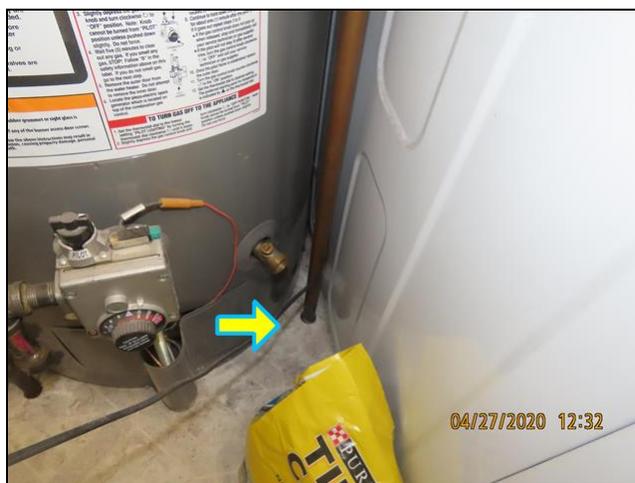
- Water heater Manufacture date: 2015
- Further evaluation of the TPR valve is strongly recommended to ensure proper conditions exist.

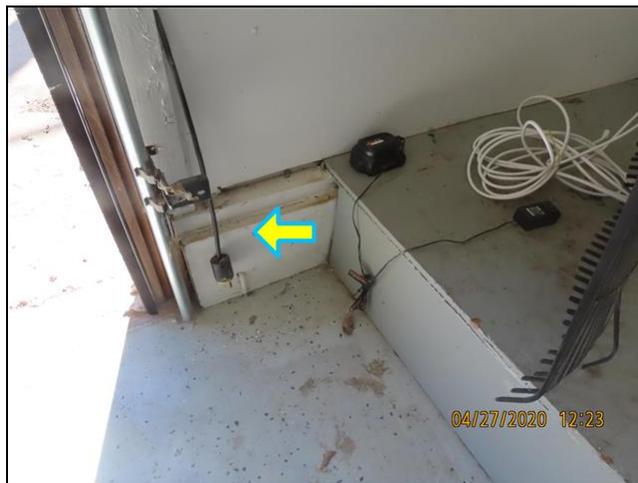
7.0 Item 2(Picture) garage, extension cord may be used at permanent wiring

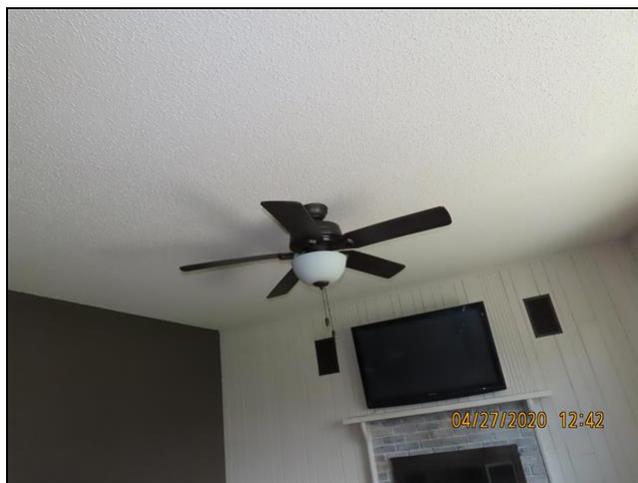
7.0 Item 4(Picture) main floor living room light, not responding

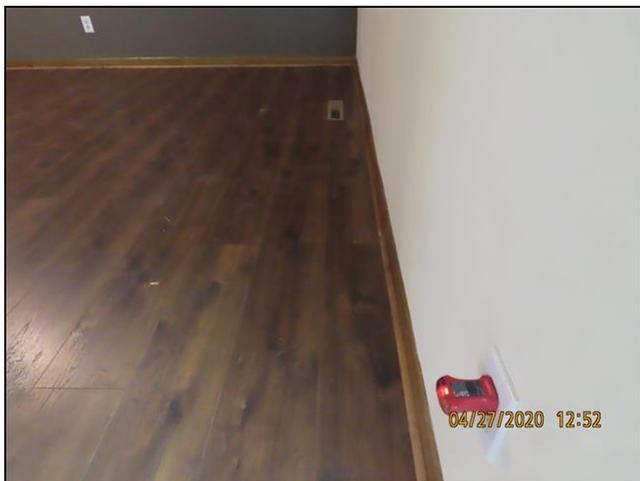
7.3 Item 1(Picture)

- The home does not appear to have AFCI breakers
- Garage does not appear to have GFCI breakers
- Lack of GFCI at laundry room
- Item 1(Picture) 2-prong outlet(s) in upstairs bedroom
-

a GFCI receptacle. 3. Replacing the breaker currently protecting the electrical circuit that contains the receptacles of concern with a GFCI breaker. Adding equipment grounding and a service grounding system will also increase home safety.

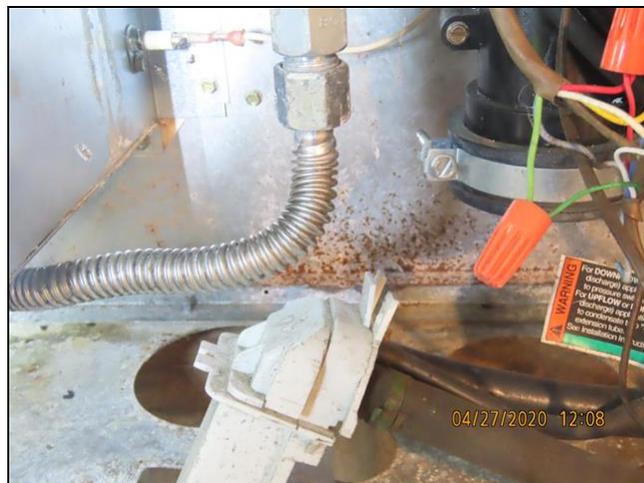
8.0 Item 2(Picture)

(2) Corrosion visible at the furnace is indication that high moisture levels once existed. The area was dry at time of inspection however a qualified HVAC technician should confirm this finding and in sure the source is not intermittent.

- Inspector was not able to determine when the furnace was last serviced.

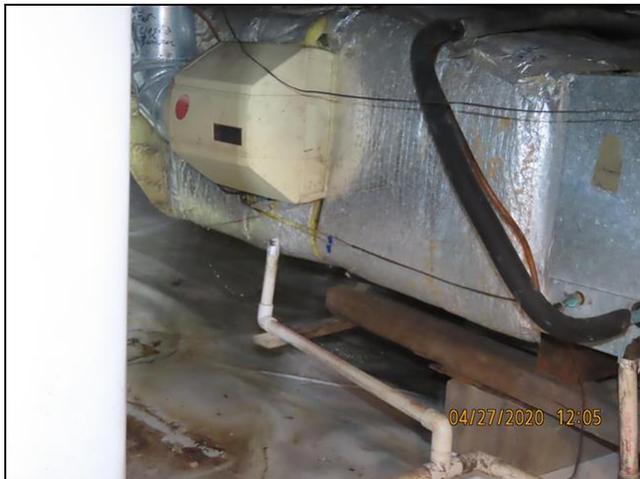
8.1 Item 1(Picture)

- Crack a window open
- Install vent fans in kitchen
 - Item 1(Picture) Full inspection of the April air system goes beyond the scope of the home inspection. The component did not appear to be properly installed or may be abandoned. You may wish to ask seller about this condition or have a qualified HVAC technician confirm this finding to ensure proper humidity levels exist with in the home.
 - Stains at several areas at the interior of home indicate possible high moisture levels. Further evaluation is strongly recommended.

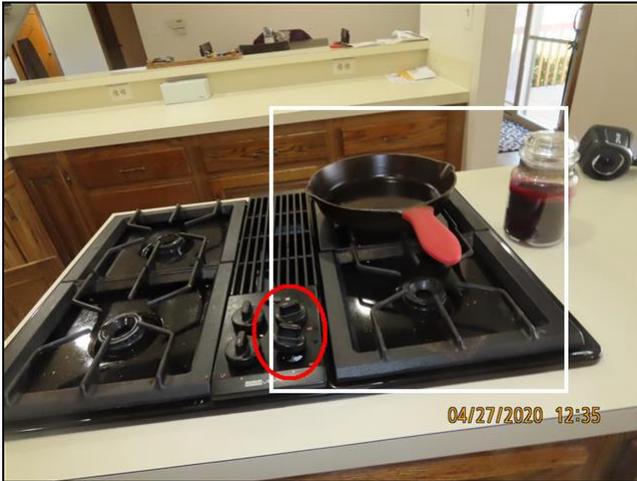
- The cook top, at kitchen, was not responding as designed. The handles on right side burners where damaged. Further evaluation and correction would be needed by a qualified technician. You may wish to obtain a cost estimate before the end of your inspection deadline.

11.5 Item 1(Picture) two burners not responding, hardware damaged.

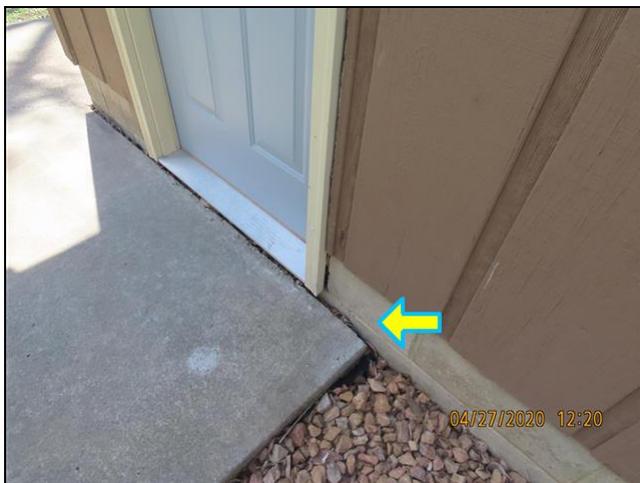
2.6 Item 1(Picture)

(2) The joint at which concrete walkways met the exterior walls should be maintained. Gaps and cracks should be sealed to reduce chance of further cracking or moisture near the foundation.

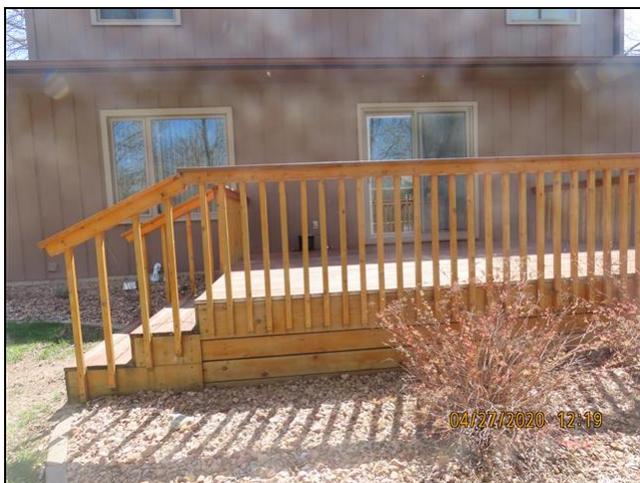
2.8 Item 1(Picture) rear of home

- Exterior stairs should be maintenance to increase life span.
- Item 1(Picture) Areas of the deck were in contact with soil at front and rear of home. This condition will result in damage from decay. The inspector recommends correction to extend the service life of this deck.
- Finish coating designed to protect the deck at front and rear of home was not present. Failure to apply a finish coating will allow Ultra Violet (UV) radiation from sunlight, heat, moisture and freezing moisture to reduce the life span of bare wood exposed to weather. Maintenance performed on an appropriate schedule can significantly extend the life span of wood deck components. The Inspector recommends that wood components be re-finished as needed.
- The deck at rear of home showed moderate wear and tear commensurate with age.

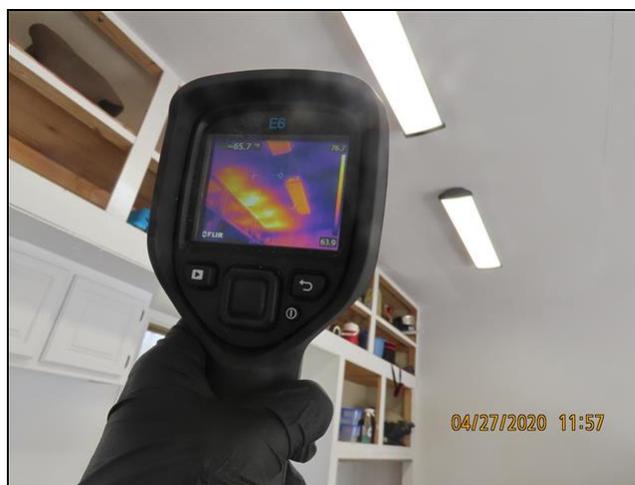
3.2 Item 2(Picture)

Garage wall(s)/ceiling exhibited evidence of damages. The moisture meter showed no elevated levels of moisture in the ceiling materials at the time of the inspection, indicating that leakage has not been recent. The source may be an indication of leakage has been corrected or may be intermittent. You should ask the seller about this condition or have a qualified contractor confirm this finding after a heavy rainfall.

- Damage to the garage ceiling and localized area Observed at time of inspection. The FLIR Thermal camera indicated possible missing insulation in this area . You may wish to ask seller about this condition or have a qualified contractor confirm this finding and to ensure proper conditions exist year round.

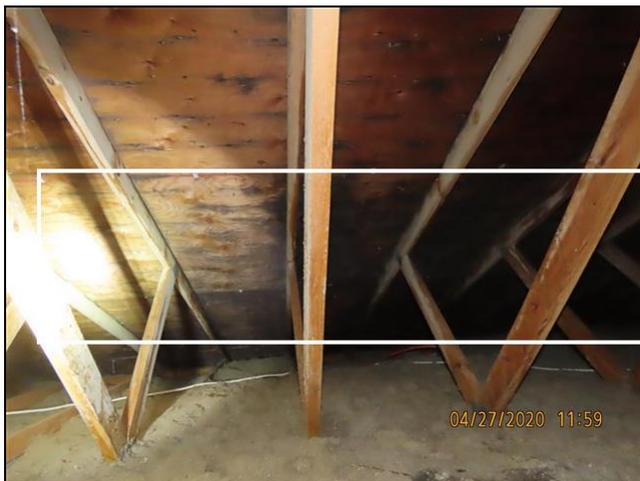
3.12 Item 1(Picture)

- Item 1(Picture) Item 4(Picture) Discoloration/staining in areas (appeared more than 15sq ft) - further evaluation needed to ensure dry conditions exist year round.
- Item 2(Picture) Deterioration in attic space in area(s) is indication of possible past/intermittent moisture or high condensation levels.
- Item 3(Picture) - Exposed electrical in 2 areas should be further evaluated by a qualified electrician to ensure proper conditions exist.

Inspector recommends for their evaluation of the attic space above the garage by a qualified contractor to ensure proper conditions exist. Determining future moisture goes beyond the scope of a home inspection.

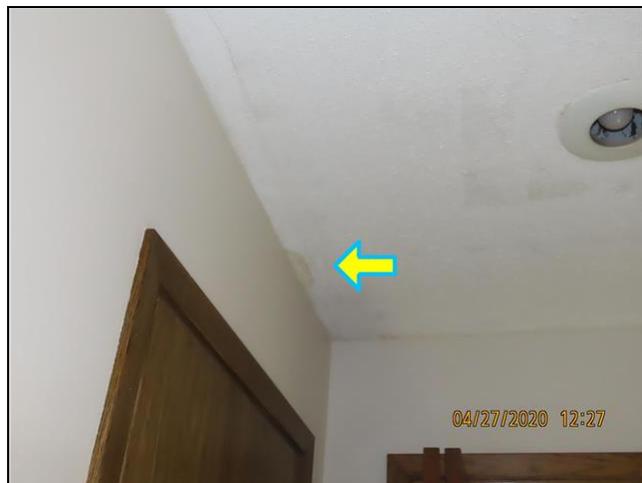
(2) Stains on the ceiling in 7 or more in areas visible at the time of the inspection appeared to be the result of moisture intrusion. The moisture meter showed no elevated moisture levels in the affected areas at the time of the inspection. Although this condition indicated that the source of moisture may have been corrected, further examination by a qualified contractor would be required to provide confirmation.

4.3 Item 2(Picture) stain at ceiling near rear entry (leading to garage), area appeared to have been recently painted

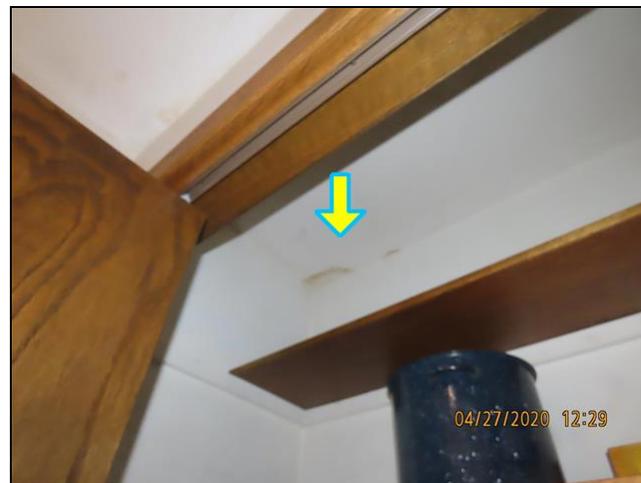
4.3 Item 3(Picture) stain at ceiling near rear entry (leading to garage), in closet

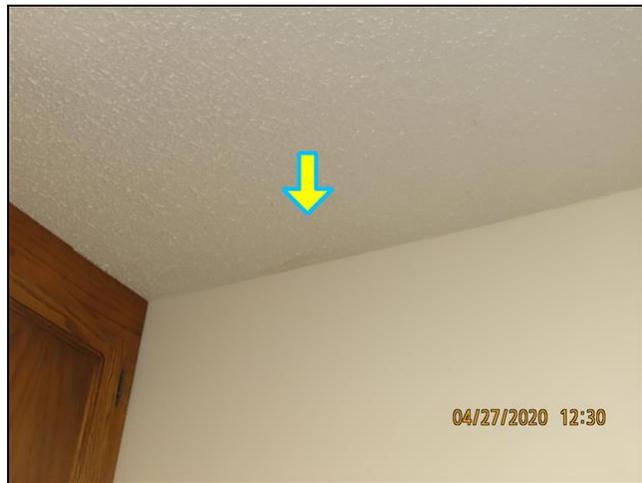
4.3 Item 4(Picture) stain at ceiling, laundry room ceiling

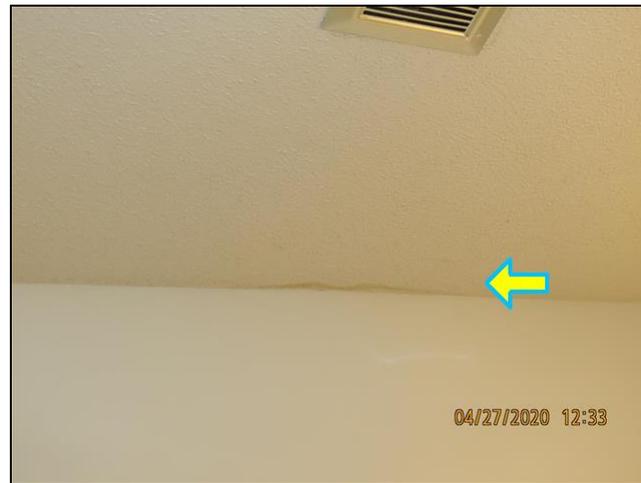
4.3 Item 5(Picture) main floor bathroom ceiling (2 locations)

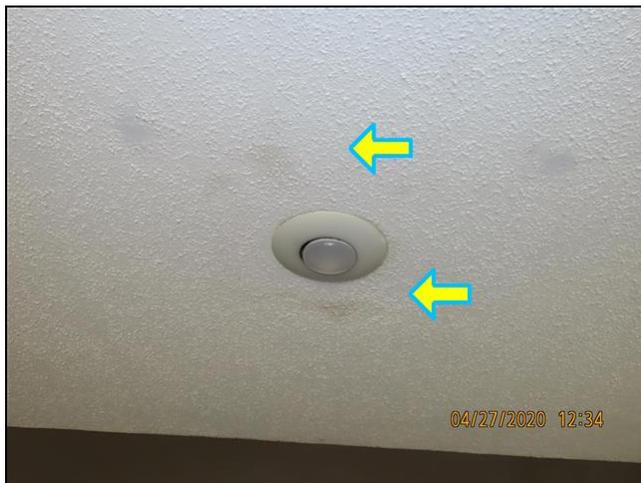
4.3 Item 6(Picture) kitchen ceiling

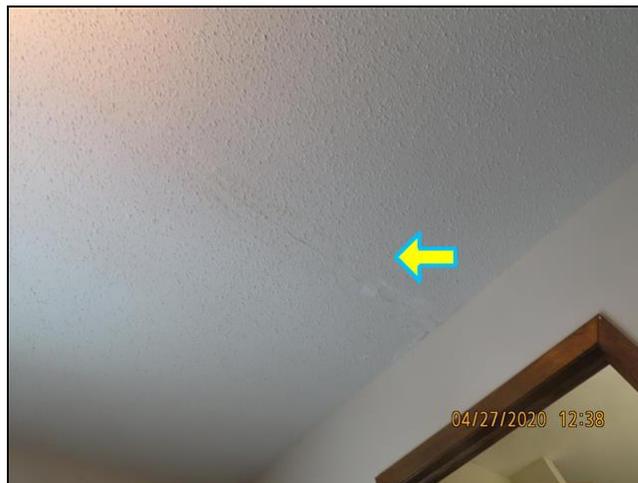
4.3 Item 7(Picture) stain, damage - living room ceiling

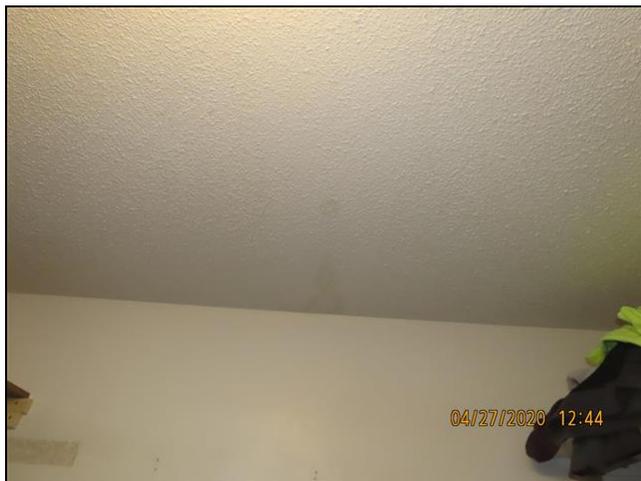
4.3 Item 8(Picture) main floor (master bedroom) closet

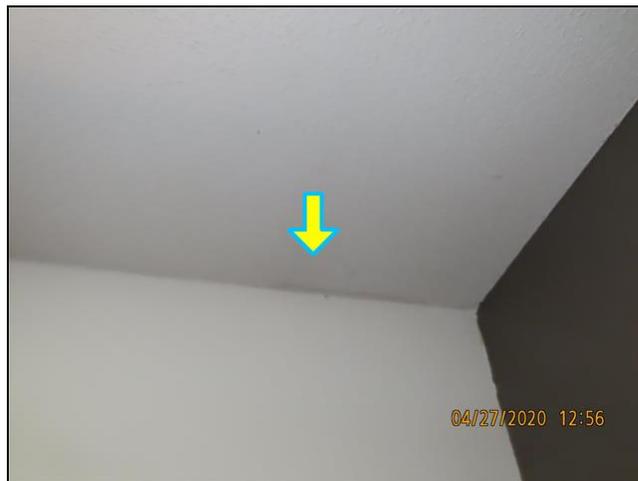
4.3 Item 9(Picture) upstairs hallway bedroom ceiling

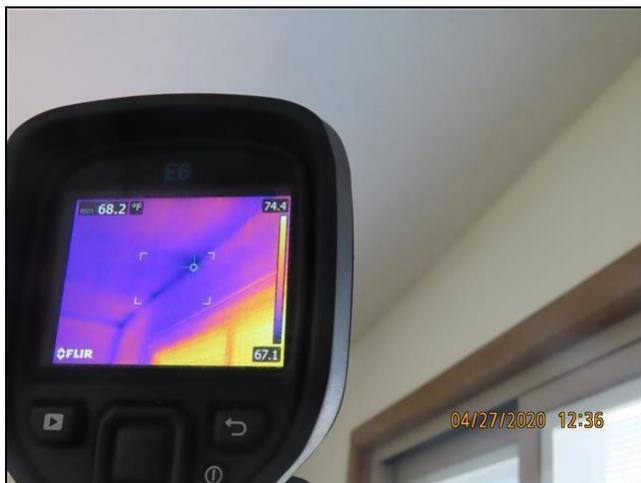
- Item 10(Picture) stain at dining room ceiling - appears to have energy loss in the area. Further evaluation of all moisture stains should be further evaluated.

4.3 Item 10(Picture) stain at dining room ceiling

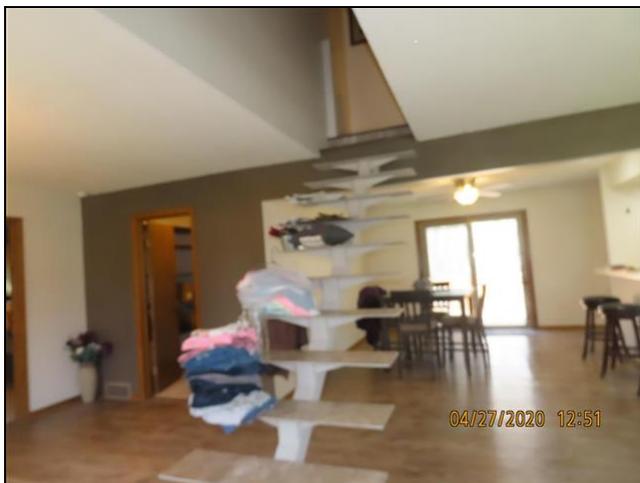
4.8 Item 1(Picture)

Missing handrail leading to basement can create a potential fall hazard, especially for the elderly or young children. A handrail should be installed to protect this stairway by a qualified person or professional.

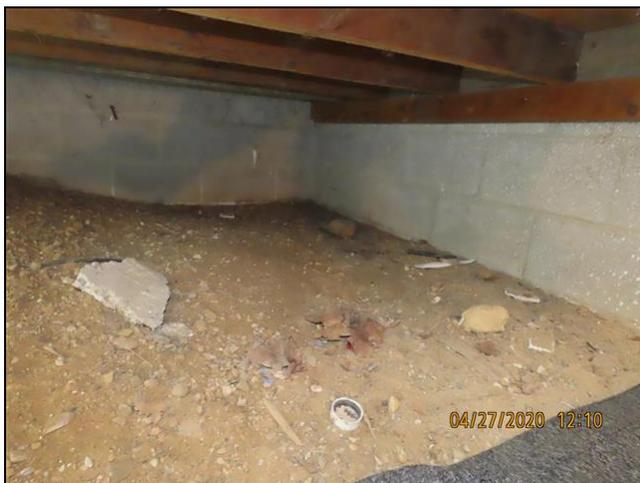
5.4 Item 1(Picture)

(1) The crawlspace, access located in the garage, did not appear to have a full vapor barrier. Inspector recommends a full vapor barrier near the entrance to reduce chance of moisture or possible harmful gases.

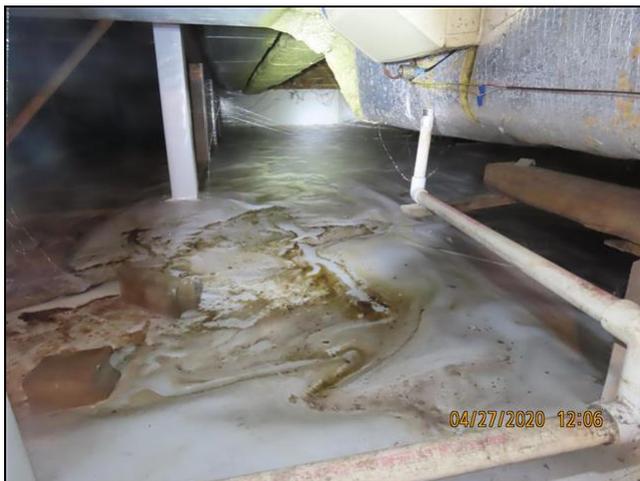
5.4 Item 2(Picture)

(2) Stains on the floor (active in localized areas) in the crawlspace visible at the time of the inspection appeared to be the result of moisture. The moisture meter showed elevated moisture levels in the affected areas at the time of the inspection, indicating that the leakage has been recent. The Inspector recommends consultation with a qualified contractor to discuss options and costs for correction and repair.

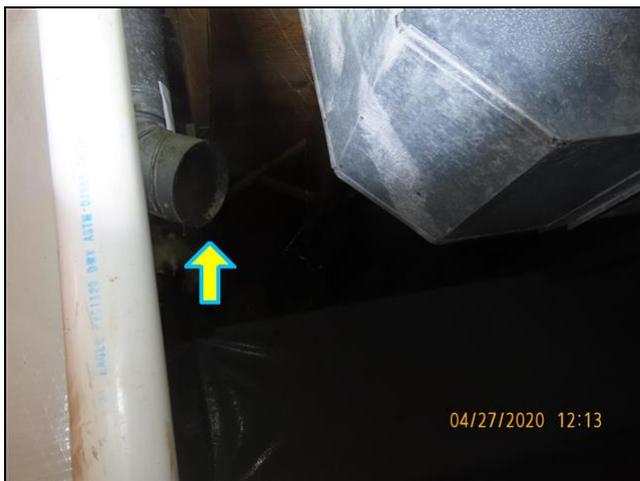
5.4 Item 3(Picture)

(4) Inspector observed a vent in the crawlspace that appeared to be connected (in use) with the laundry room. This condition may result in un-favorable conditions such as high moisture level which can lead to microbial growth or moisture damages. Inspector recommends further evaluations to ensure proper conditions exist by a qualified professional or HVAC contractor.

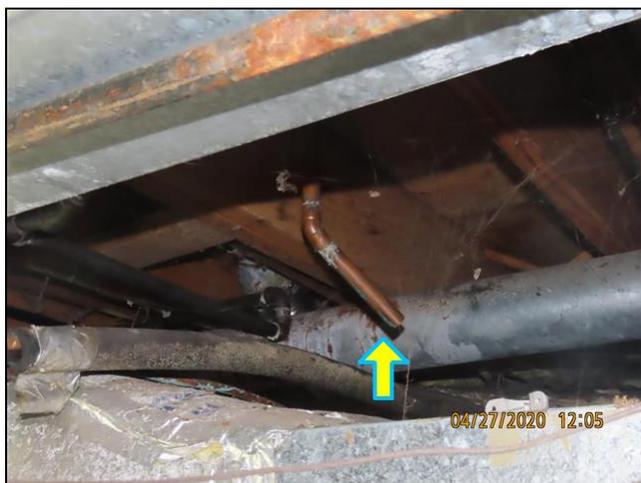
6.2 Item 1(Picture)

- It appears a discharge pipe drains to the crawl space which may create moisture damage.
- Work performed by persons not familiar with standards of practice may contain hidden defects.

(1) Inspector recommends further evaluation by a qualified plumber or professional to ensure proper conditions exist.

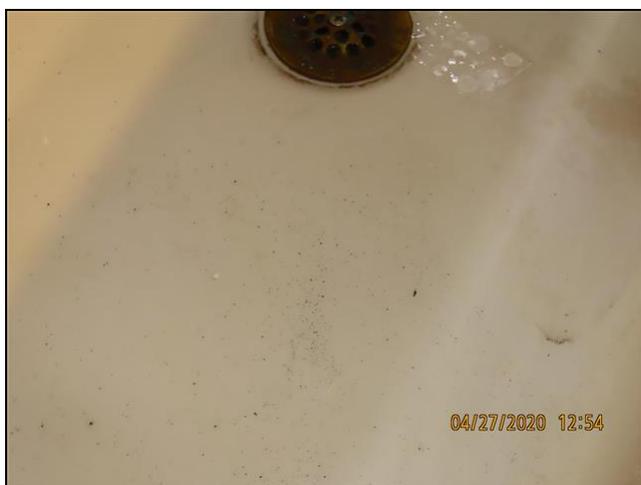
(3) Inspector observed what appeared to be debris in the water supply at upstairs bathroom when the water source was turned on. Determining exact cause goes beyond the scope of a home inspection. A qualified plumber should confirm this finding to ensure proper conditions exist.

6.2 Item 6(Picture) debris in water supply, upstairs bathroom

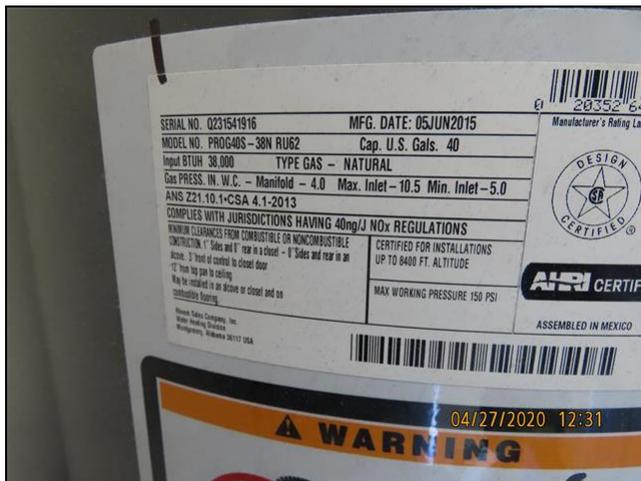
6.3 Item 1(Picture)

- Current water temp 130F - Reduce to 120F
- Water heater Manufacture date: 2015
- Further evaluation of the TPR valve is strongly recommended to ensure proper conditions exist.

The EPA (Environmental Protection Agency) recommends setting your water heater at 120 degrees to prevent burns.

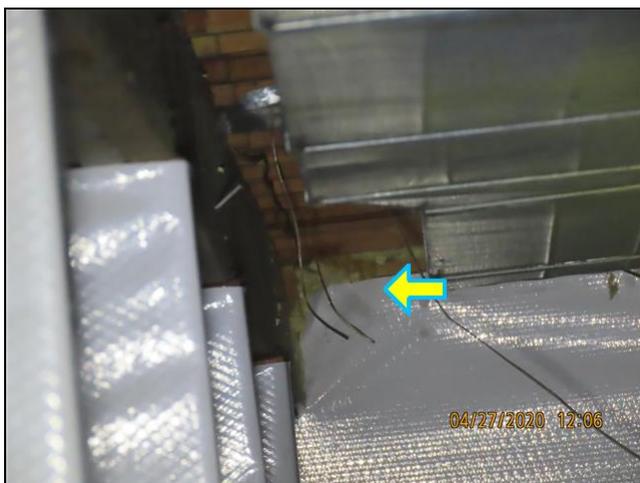
- Item 2(Picture) In the garage, an electrical cord was visible and should be further evaluated to ensure proper conditions exist. You may wish to ask seller about this condition.
- Item 1(Picture) Abandoned electrical component(s) in the crawlspace is indication that for their evaluation is needed by a qualified electrician to ensure proper conditions exist.

7.0 Item 1(Picture) exposed wiring, visible from crawlspace

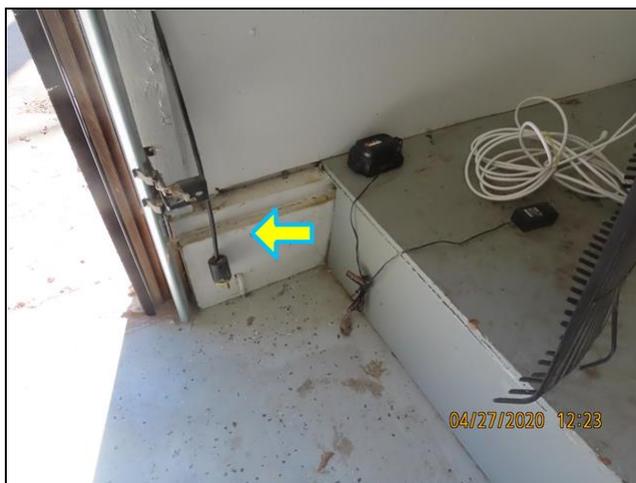
7.0 Item 2(Picture) garage, extension cord may be used at permanent wiring

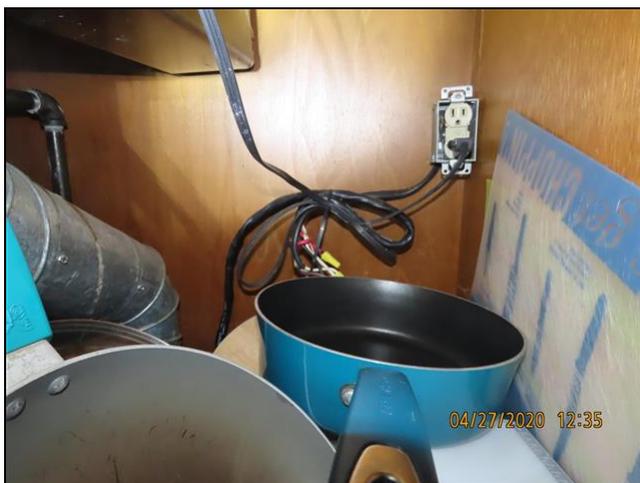
7.0 Item 3(Picture) under kitchen sink

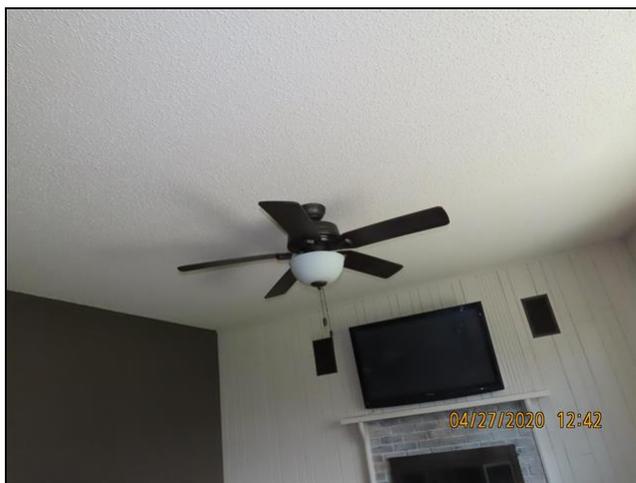
7.0 Item 4(Picture) main floor living room light, not responding

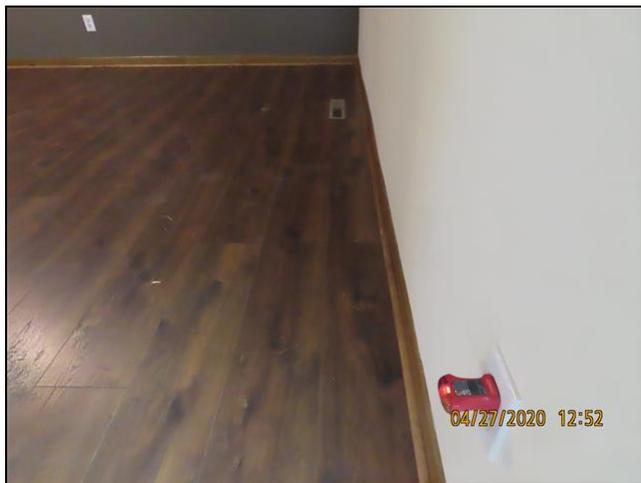
7.3 Item 1(Picture)

The home contained a partially outdated, ungrounded 2-prong electrical receptacle(s). Although this condition may have been commonly considered safe or acceptable at the time the home was originally constructed, as general knowledge of safe building practices has improved with the passage of time, building standards have changed to reflect current understanding. For safety reasons, the Inspector recommends that receptacles located in basements, crawlspaces, garages, the home exterior, and interior receptacles located within 6 feet of a plumbing fixture be provided with ground fault circuit interrupter (GFCI) protection in good working order to avoid potential electric shock or electrocution hazards. This can be achieved relatively inexpensively by: 1. Replacing an individual standard

- The home does not appear to have AFCI breakers
- Garage does not appear to have GFCI breakers
- Lack of GFCI at laundry room
- Item 1(Picture) 2-prong outlet(s) in upstairs bedroom
-

receptacle with a GFCI receptacle. 2. Replacing the electrical circuit receptacle located closest to the overcurrent protection device (usually a breaker) with a GFCI receptacle. 3. Replacing the breaker currently protecting the electrical circuit that contains the receptacles of concern with a GFCI breaker. Adding equipment grounding and a service grounding system will also increase home safety.

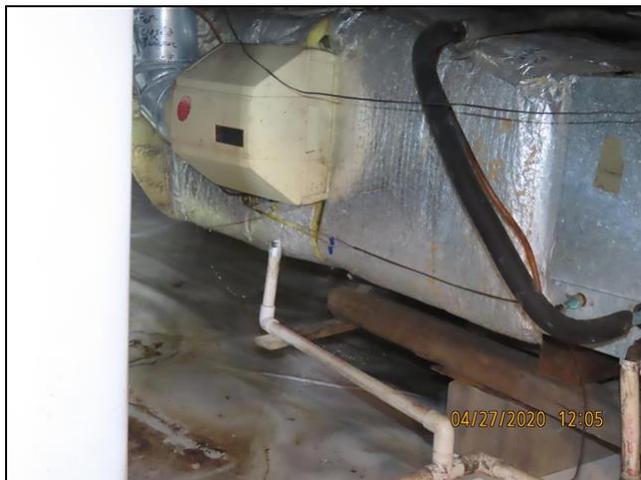
8.1 Item 1(Picture)

(1) Humidity levels above 70%RH are known to be optimum conditions for dust mites and mould to grow. The ideal indoor humidity is between 45 to 55%RH and should always be maintained between 40 to 60%RH.

- Run a dehumidifier
 - Avoid activities that add moisture to the air on humid days, such as taking hot showers and boiling water on the stove
 - Keeping gutters and downspouts clean, extending downspouts further from the house, watering plants only when needed and sloping soil away from foundations to keep water from pooling
 - Line dry clothes outdoors
 - Crack a window open
 - Install vent fans in kitchen
- Item 1(Picture) Full inspection of the April air system goes beyond the scope of the home inspection. The component did not appear to be properly installed or may be abandoned. You may wish to ask seller about this condition or have a qualified HVAC technician confirm this finding to ensure proper humidity levels exist with in the home.
 - Stains at several areas at the interior of home indicate possible high moisture levels. Further evaluation is strongly recommended.

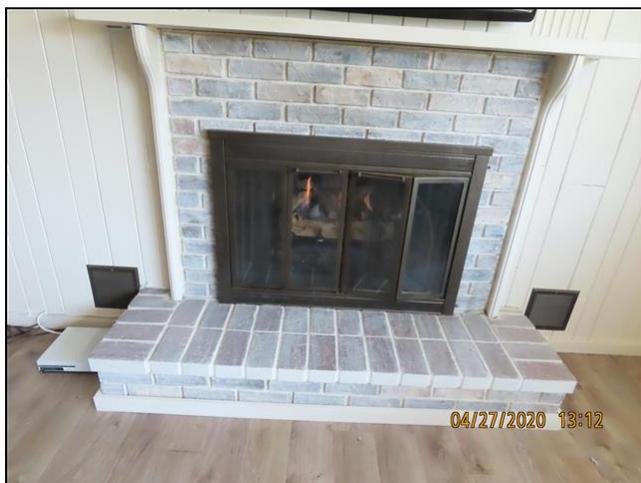
8.4 Item 1(Picture)

The gas fireplace requires invasive, technically exhaustive measures that exceed the scope of the General Home Inspection.

- Recommend service by a qualified contractor on a regular maintenance basis and before your first use. Find a CSIA-certified inspector near you at <http://www.csia.org/search>
- The fireplace appeared to be in working order using remote control to turn on the gas fireplace.

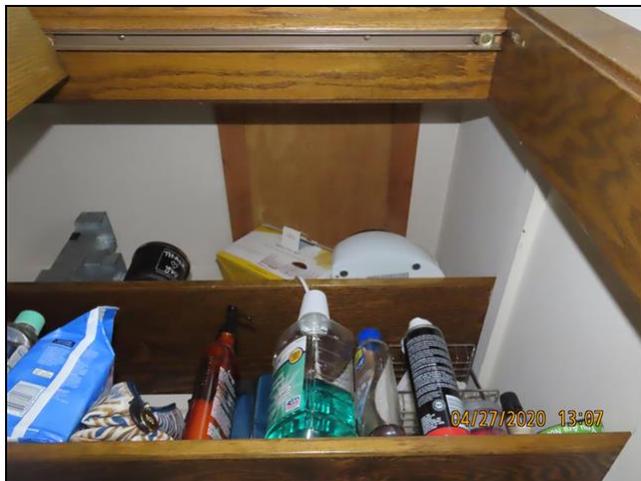
9.0 Item 1(Picture)

(2) One of the attic access hatch's was located in a closet and access was blocked by the occupant's belongings. Moving stored items lies beyond the scope of the General Home Inspection. The Inspector recommends that the attic be inspected after access to the attic entry hatch has been provided.

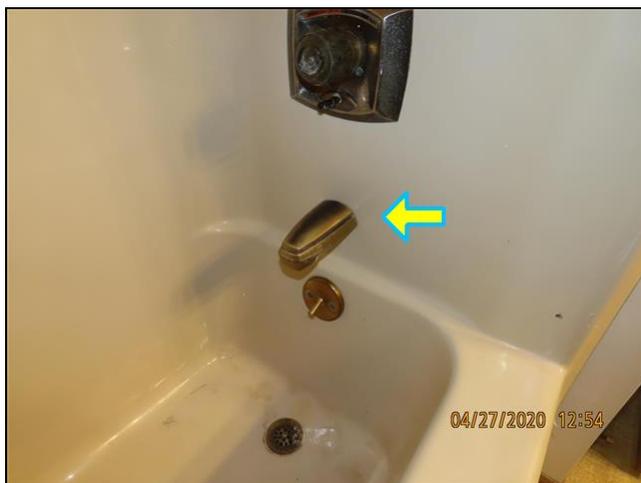
Inspector observed what appeared to be an act of we got upstairs bathroom hardware. Inspector recommends correction as needed by a qualified professional or plumber to ensure proper conditions exist.

10.0 Item 1(Picture) upstairs bathroom
